14.0 Rifle, Colorado, Disposal Site

14.1 Compliance Summary

Figure 14-1. 2006 Annual Compliance Drawing for the Rifle, Colorado, Disposal Site

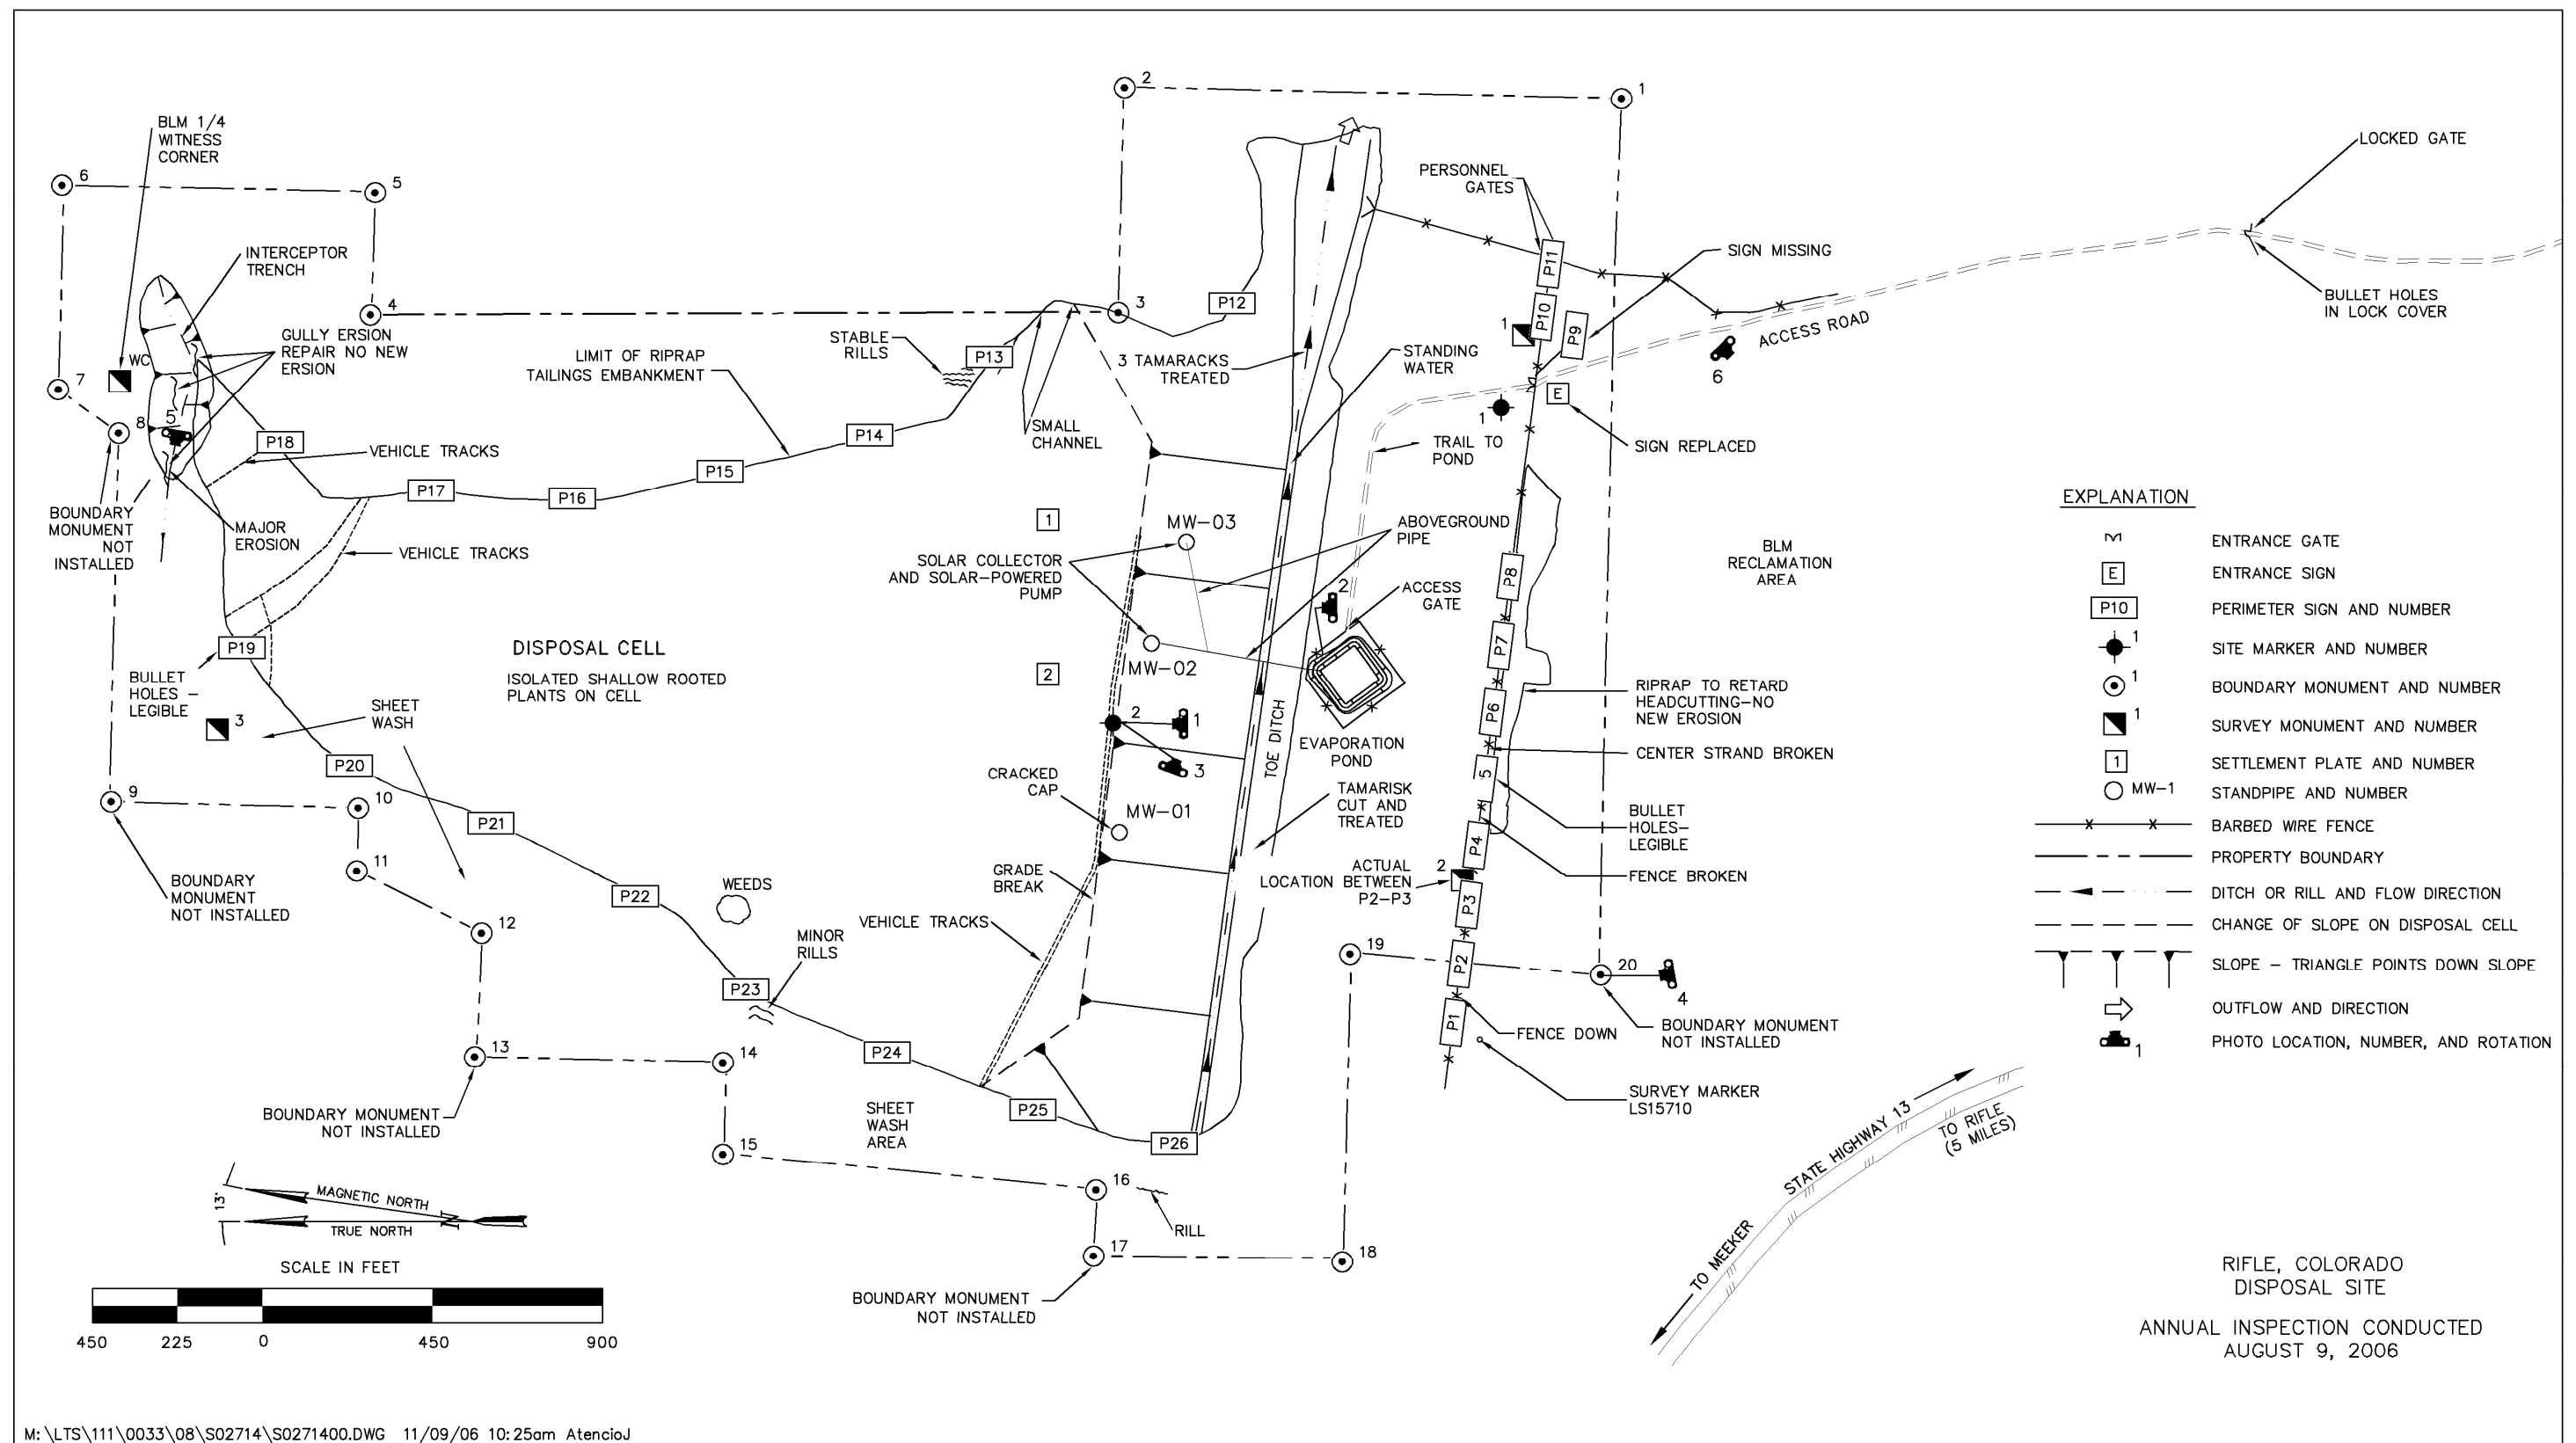
14A Access Road, Gates, Fence, and Signs—The site is accessed from a gravel road off of State Highway 13; the gravel access road is approximately a mile long and in good condition. In 2006, debris washed on to the access road from a heavy precipitation event was removed. A perpetual right of way across BLM property provides access to the site. Two gates are installed on the access road. The first gate, installed along the access road where it passes through a narrow road cut, limits site intrusion and helps prevent vandalism to the cell dewatering system. The second gate is the site entrance gate; it consists of a pair of tubular metal gates hinged to galvanized steel posts installed in the barbed-wire stock fence south of the disposal cell and evaporation pond. A chain and padlock secures both gates. The gates were both locked and in excellent condition.

The barbed-wire stock fence, which extends to the edge of steep-sided arroyos that bound the site on the east and west sides, continues to prevent cattle from entering and grazing near the cell. Minor repairs are needed along the fence, but it continues to remain functional. There was evidence of wildlife (elk and deer) crossing the fence and grazing in the revegetated areas adjacent to the disposal cell.

14B The entrance sign, again found missing at the time of the inspection, was replaced. Perimeter sign P9, that was located directly east of the entrance sign and found missing in 2005, will not be replaced. Two other perimeter signs have bullet damage but remain legible. The remaining perimeter signs were in excellent condition.
